Building Evaluation

**Norton Fire Department
69 Bay Road
Norton, Massachusetts**

Prepared by:
Massachusetts Department of Public Health
Center for Environmental Health
Emergency Response/Indoor Air Quality Program
November 2005

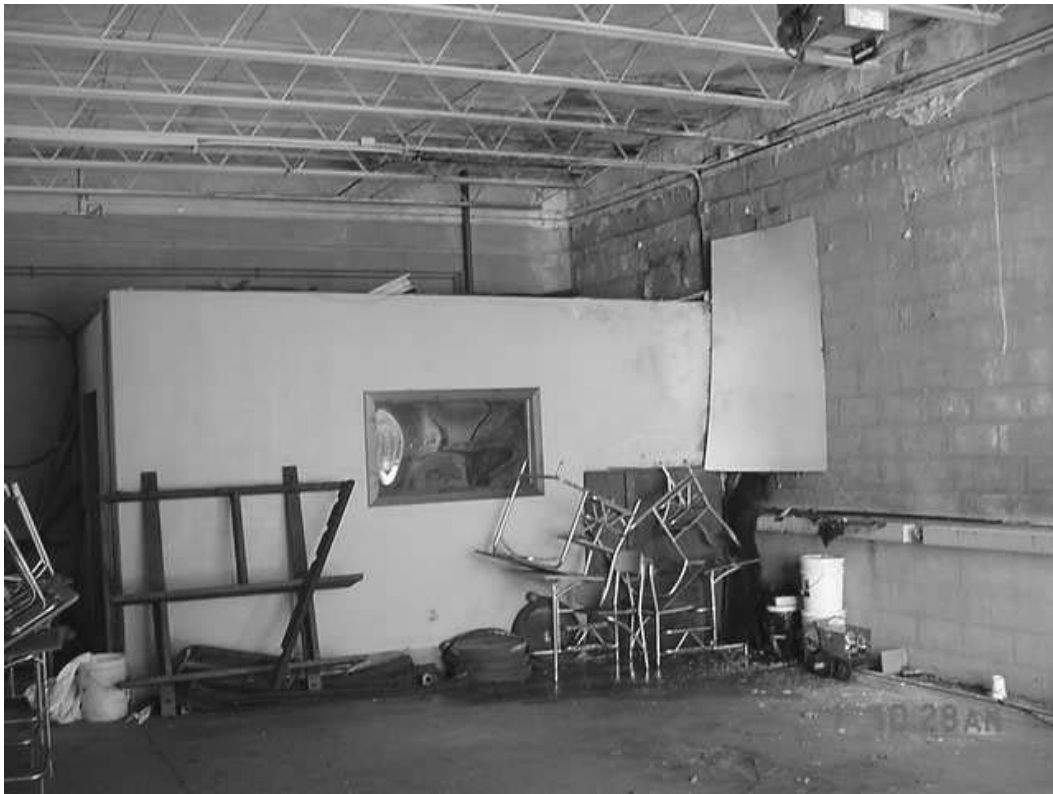
Picture 1

The Bay Road station is an uninsulated one-story cinderblock building on cement slab that was constructed in the early to mid-1950s. The station consists of an engine bay with two garage doors, an office, a dispatch area, kitchen and a restroom. Building components are original (e.g., ceilings, windows, electrical, plumbing), with the exception of the kitchen. The kitchen, made of wood and gypsum wallboard (GW) located at the rear of the engine bay was constructed at a later date. It is important to note, however, that the kitchen is severely water damaged, thus rendering it currently unusable (Pictures 1 to 3).

Kitchen built of Wood and Gypsum Wallboard in Engine Bay

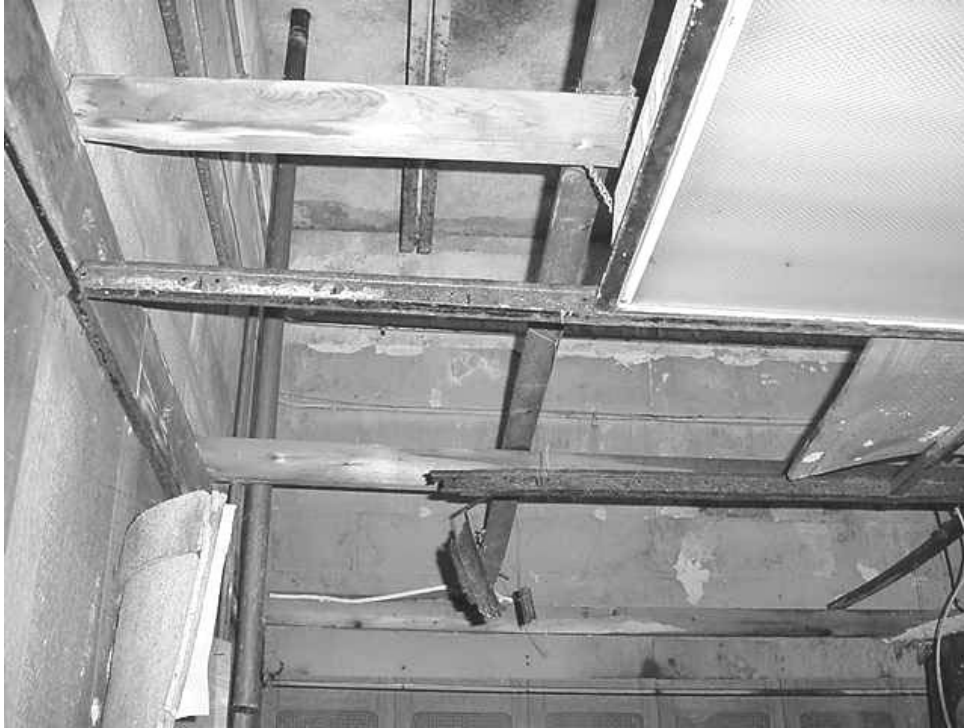
Picture 2

Frame for Ceiling Tile System of Kitchen in Engine Bay

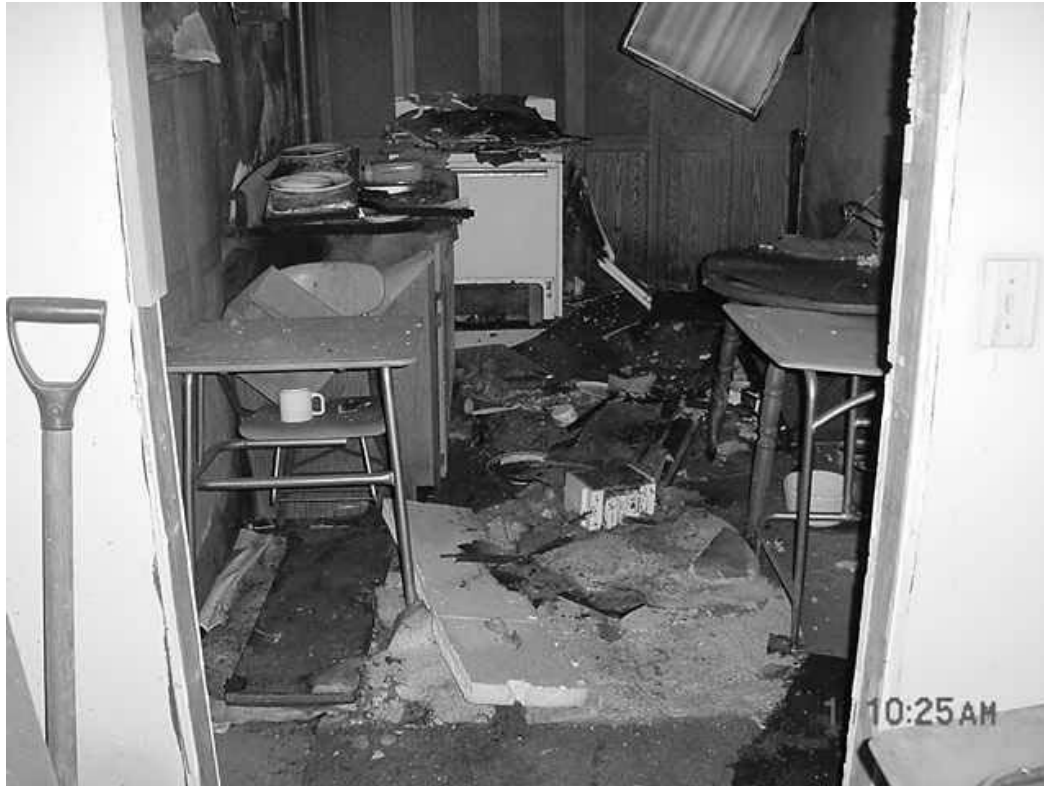
Picture 3

Extensive water damage and microbial growth was observed on porous building materials (e.g., carpeting, ceiling tiles, GW) throughout the station (Pictures 3 to 7). At the

Water Damaged/Mold Colonized Materials in Kitchen in Engine Bay, Note Ceiling Tiles on Floor that Caved in Due to Water Penetration

1. Remove and replace any mold contaminated/water damaged GW building materials (GW, carpet, ceiling tiles, etc.). This measure will remove actively growing mold colonies that may be present. Remove mold contaminated materials in a manner consistent with recommendations found in “Mold Remediation in Schools and Commercial Buildings” published by the US Environmental Protection Agency (US EPA, 2001). The document is available at the US EPA website:
http://www.epa.gov/iaq/molds/mold_remediation.html. Removing water-damaged GW and wooden trim will also provide maintenance personnel with the opportunity to observe conditions within the wall cavity and determine whether any signs of water penetration through breaches of the building envelope exist.

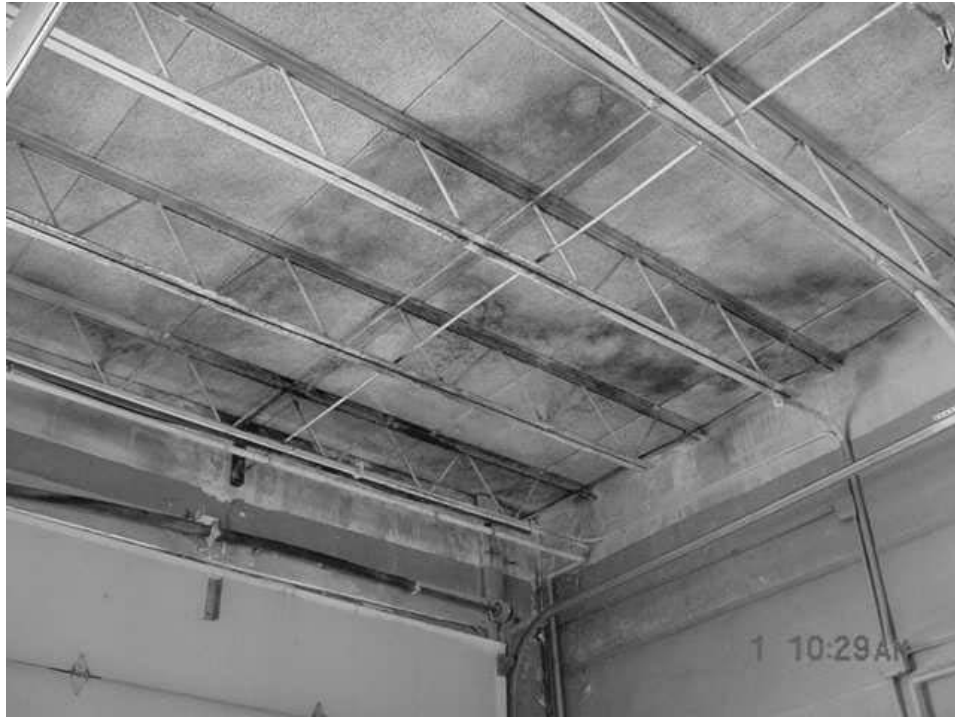
Picture 4

Mold Growth (Dark Staining) on Ceiling of Engine Bay

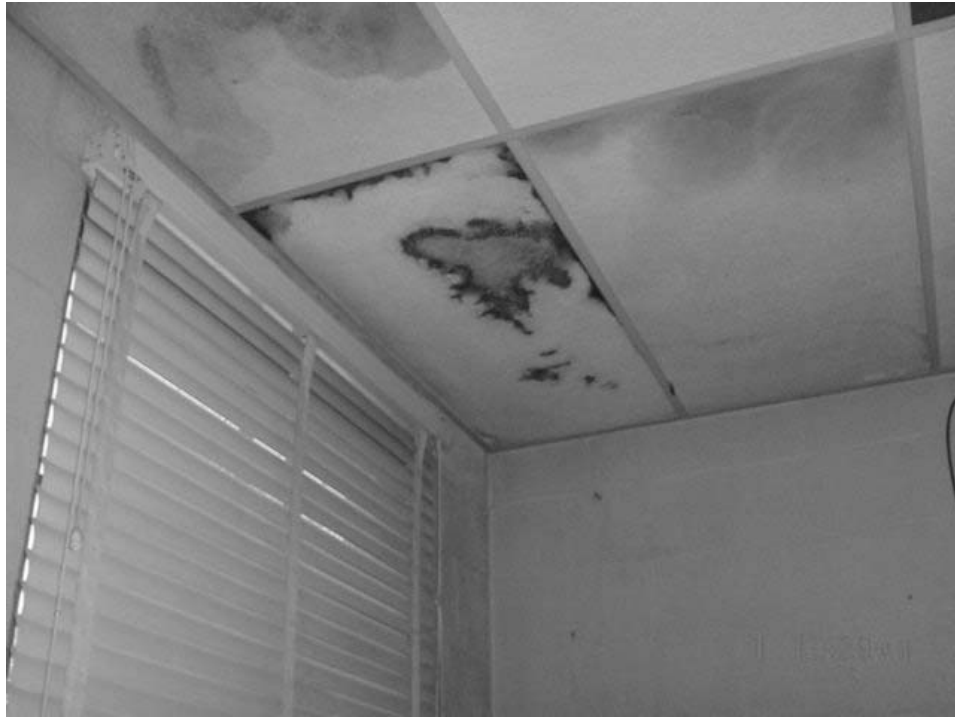
Picture 5

Water Damaged/Mold Colonized Ceiling Tiles in Dispatch Area

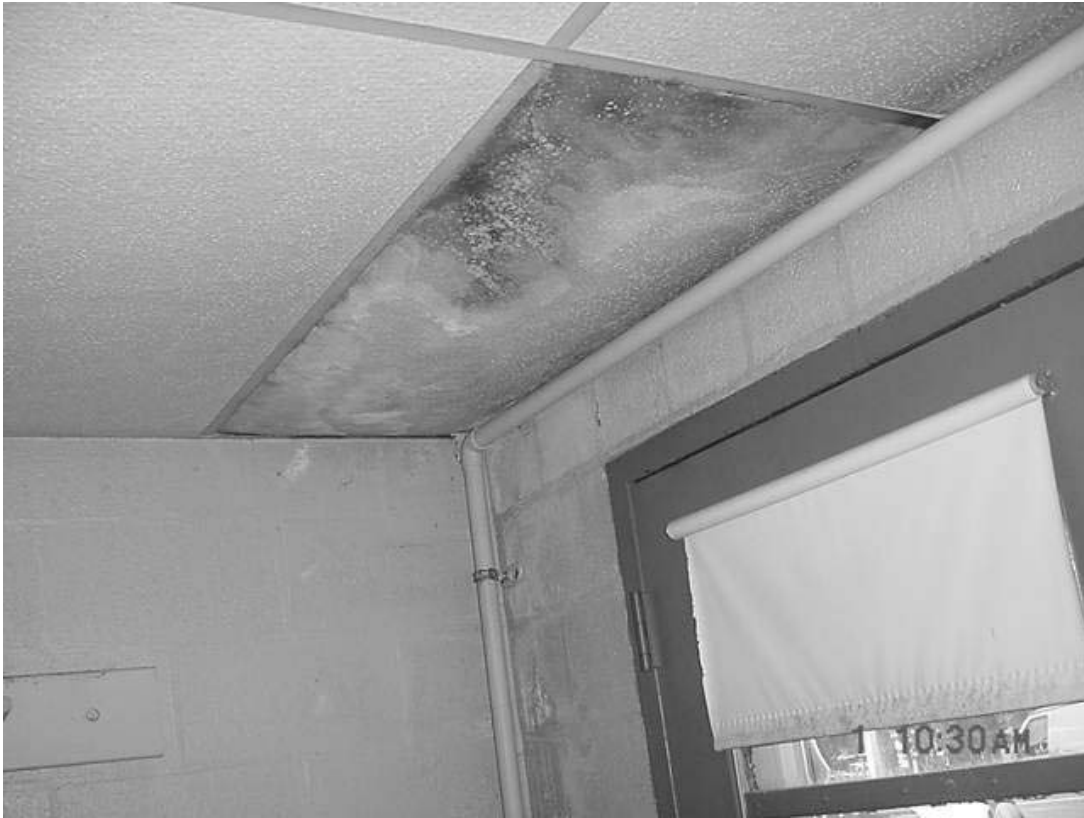
Picture 6

Water Damaged/Mold Colonized Ceiling Tiles in Office

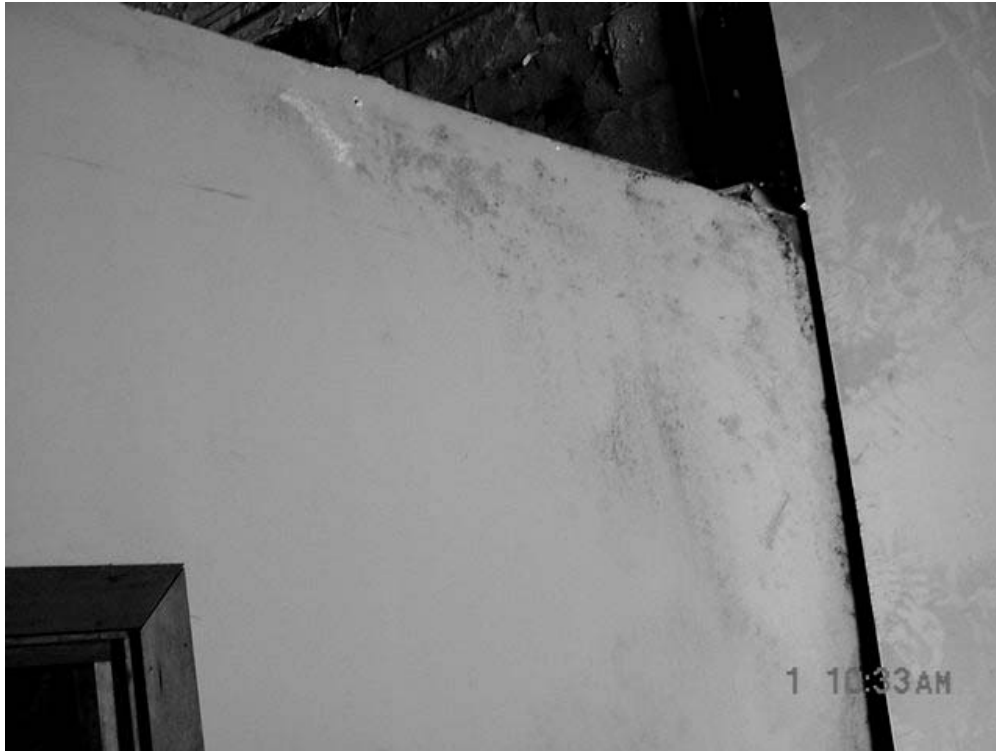
Picture 7

Mold Growth (Dark Staining) on GW in Engine Bay

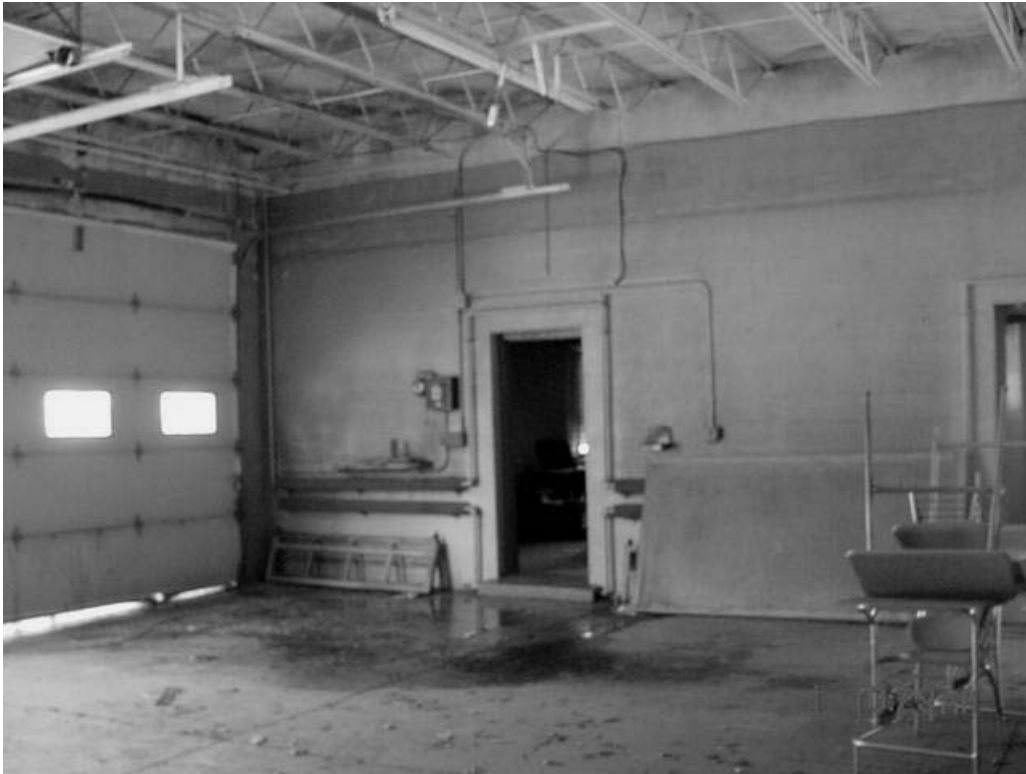
Picture 8

time of the assessment, evidence of active roof leaks in the form of standing water, was observed in a number of areas (Pictures 8 and 9).

Active Roof Leak and Standing Water on Engine Bay Floor

3. Consult with a structural engineer to evaluate the structural integrity of the building.
4. Replace roof and have structural engineer determine if the buildings support system can hold the weight of a new roof.
5. Repair/replace damaged/missing gutters and downspouts to direct rainwater away from the building.
6. Repair breaches in the building envelope including, cracks in walls and tarmac, missing/damaged flashing.
7. Repair/replace damaged garage bay doors.
8. Install local exhaust system in engine bay to remove vehicle exhaust emissions.
9. For further building-wide evaluations and advice on maintaining public buildings, see the resource manual and other related indoor air quality documents located on the MDPH's website at http://mass.gov/dph/indoor_air.

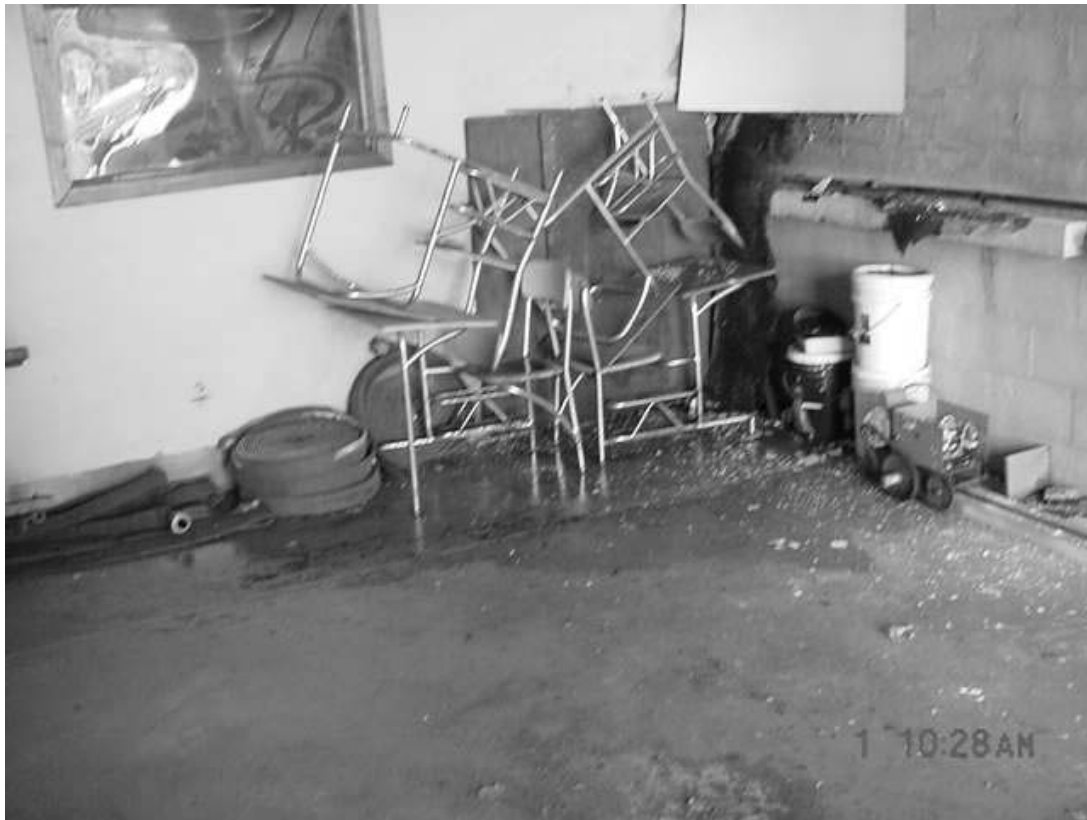
Picture 9

Active Roof Leak and Standing Water on Engine Bay Floor

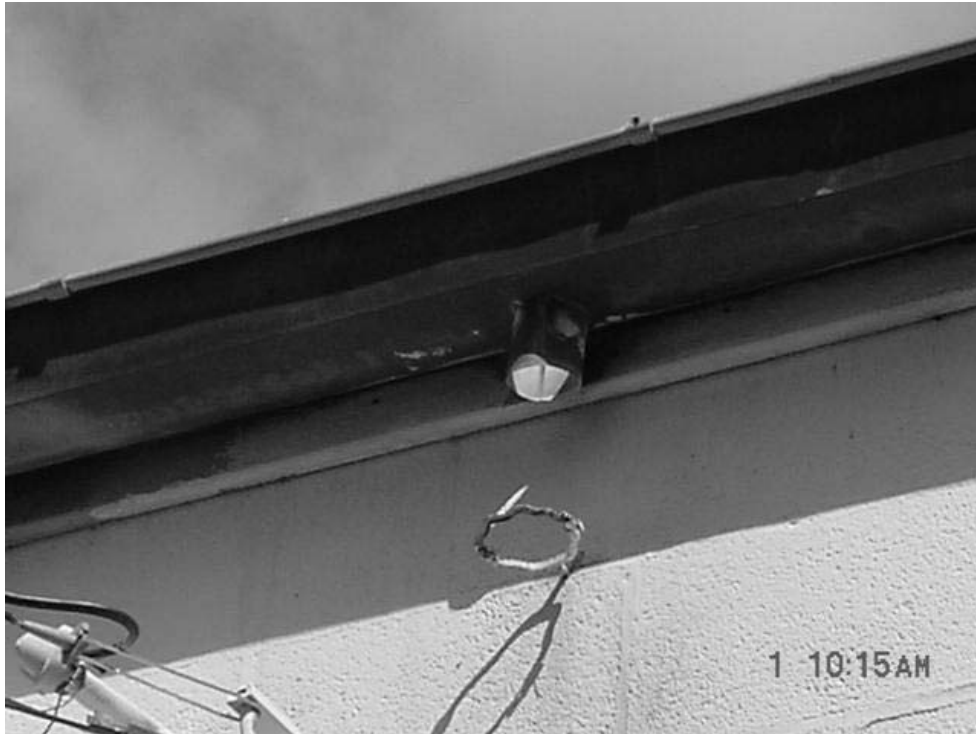
Picture 10

- Damaged/dislodged gutters and downspouts (Pictures 10 and 11).
- Cracks in the tarmac caused by plant growth between the foundation and tarmac (Pictures 12 and 13). The growth of roots along exterior walls can hold moisture and eventually lead to cracks and/or fissures.
- Rotted wooden windowsills, damaged window frames and broken/missing windowpanes (Picture 14 through 8).
- Crumbling or missing mortar around exterior brickwork (Picture 19 through 21).
- Cracked, broken or damaged cinderblocks (Pictures 21 through 23).
- Garage bay doors were off-track and did not close properly, which can also provide an entry for pests and rodents (Picture 24).

Missing Downspout to Gutter System

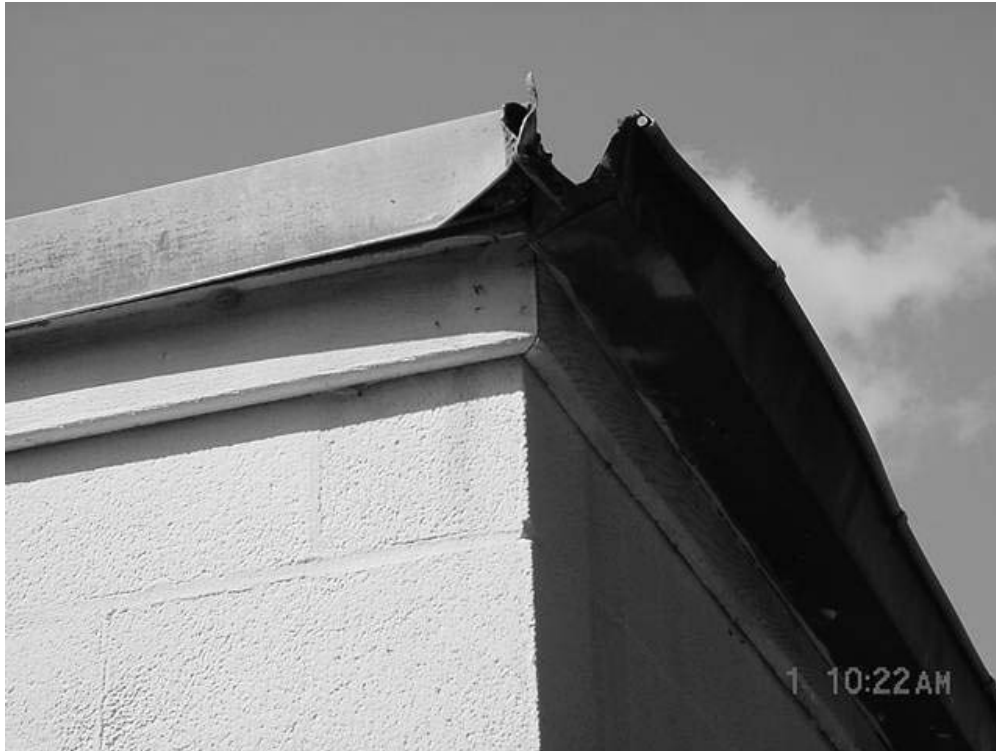
Picture 11

Damaged Gutter System

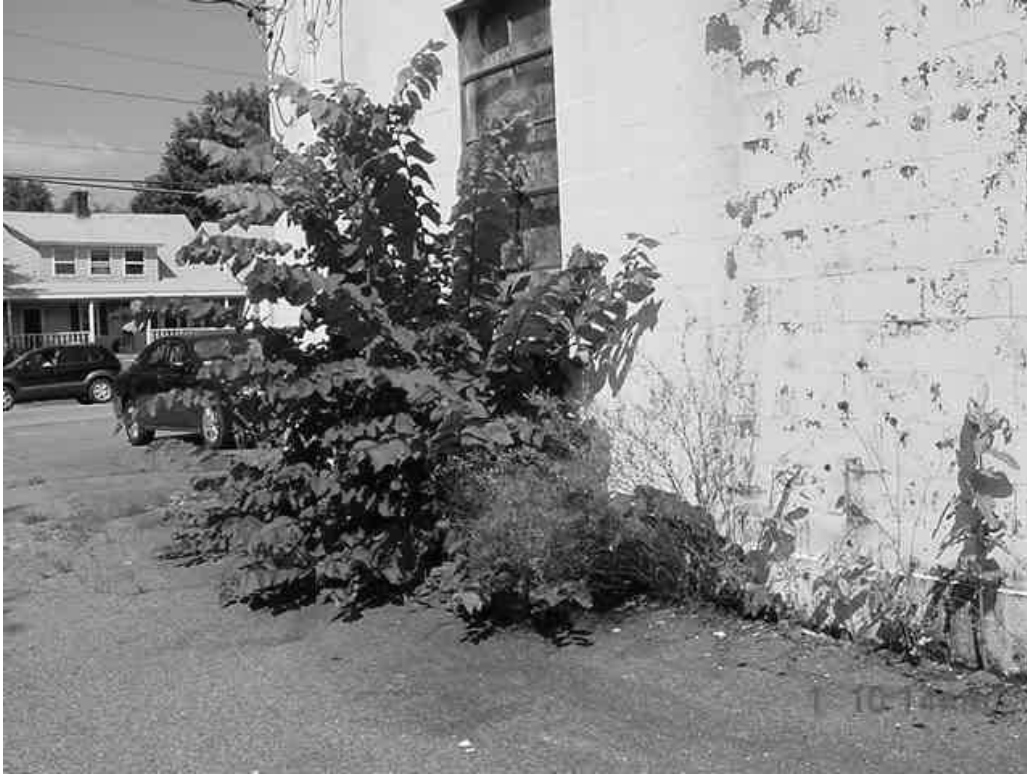
Picture 12

Tree/Plant Growth against the Building

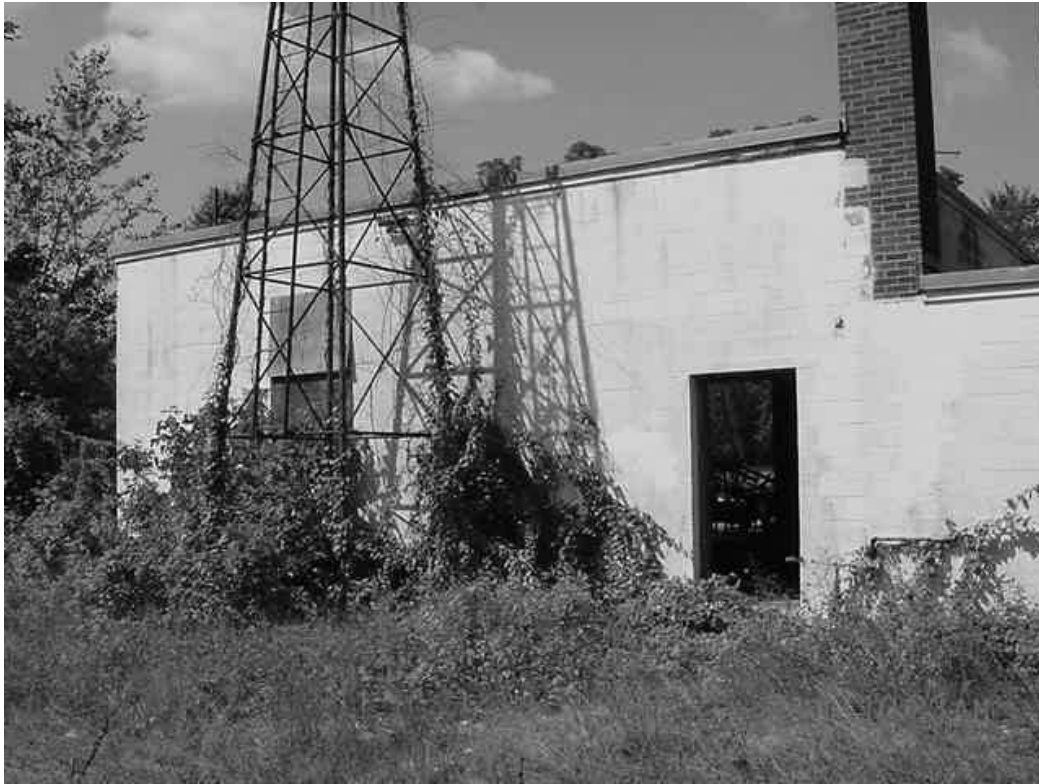
Picture 13

Tree/Plant Growth against the Building

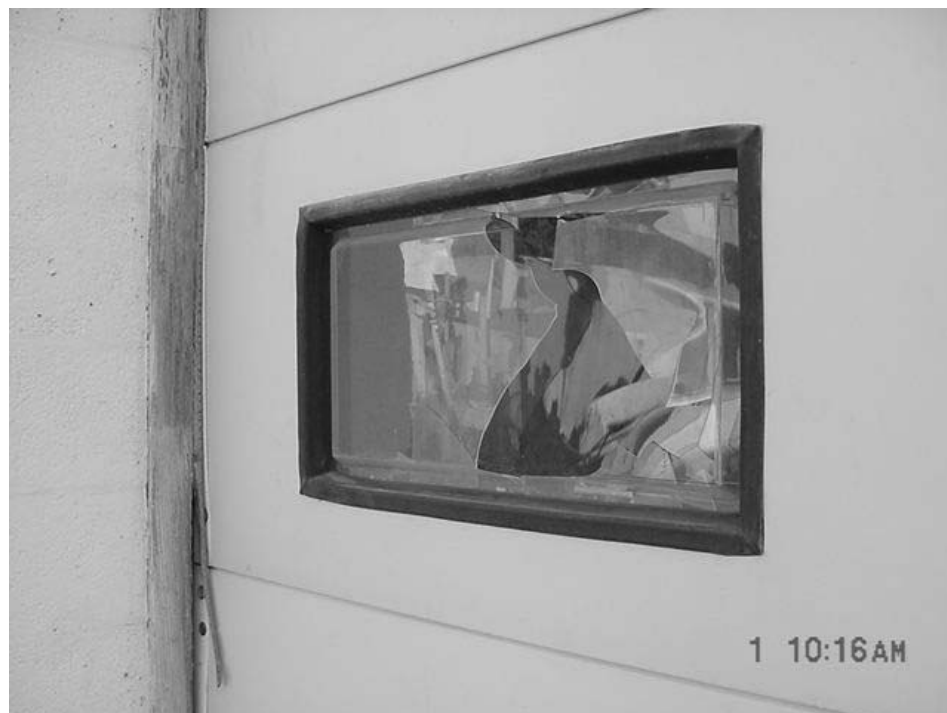
Picture 14

Broken Window on Garage Door

2. Repair/replace damaged windows and window frames to prevent water penetration. Due to the age of the building, certain window materials (i.e., caulking) may contain

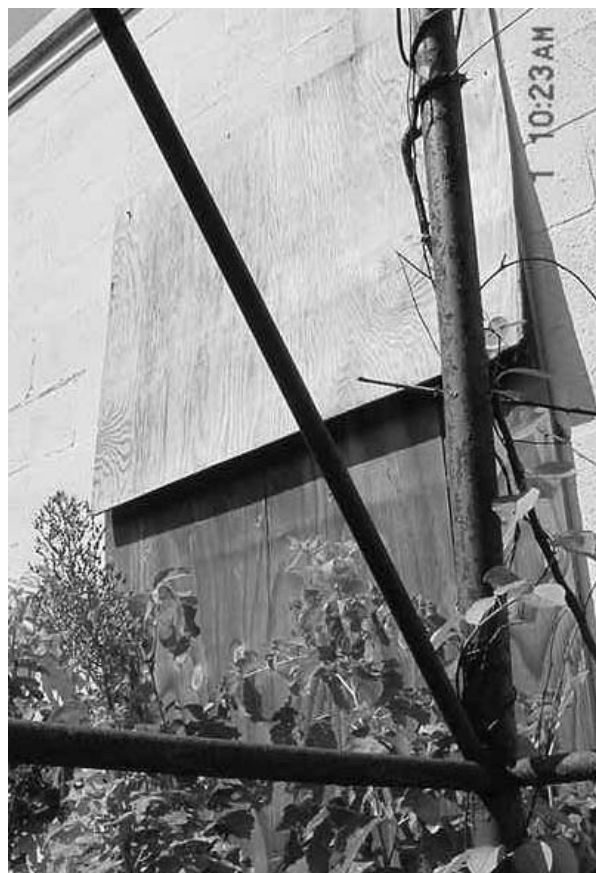
Picture 15

Boarded Up Window

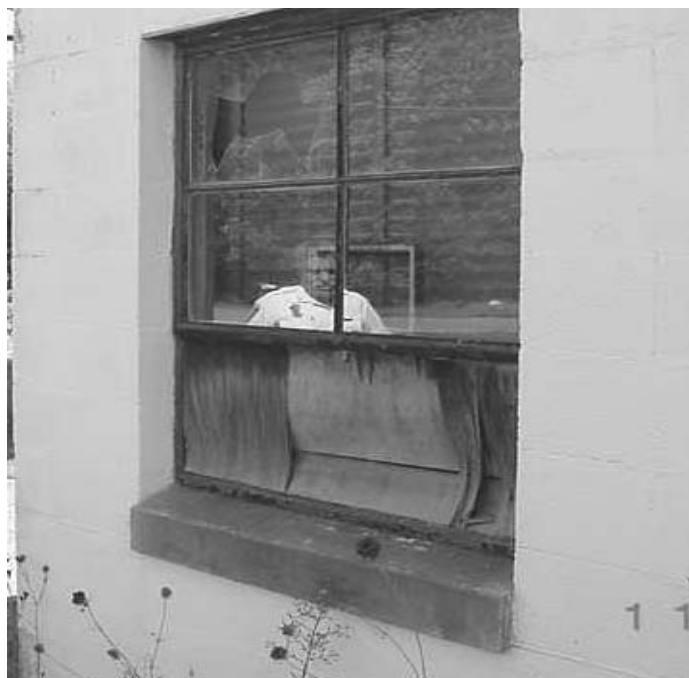
Picture 16

Broken/Boarded Up Windows

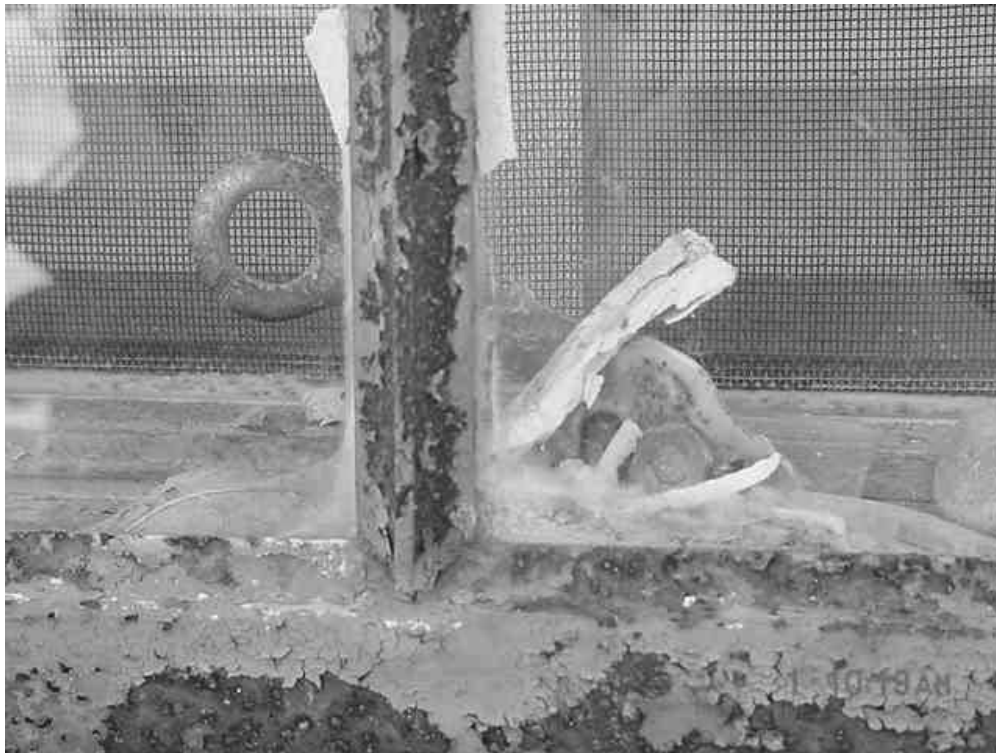
Picture17

Missing Damaged Caulking around Window Panes

asbestos. Contact the Massachusetts Department of Labor and Workforce Development, Division of Occupational Safety (DOS), Asbestos Program and/or a licensed asbestos abatement contractor to identify and remediate potential asbestos containing materials in conformance with all applicable Massachusetts asbestos abatement and hazardous materials disposal laws.

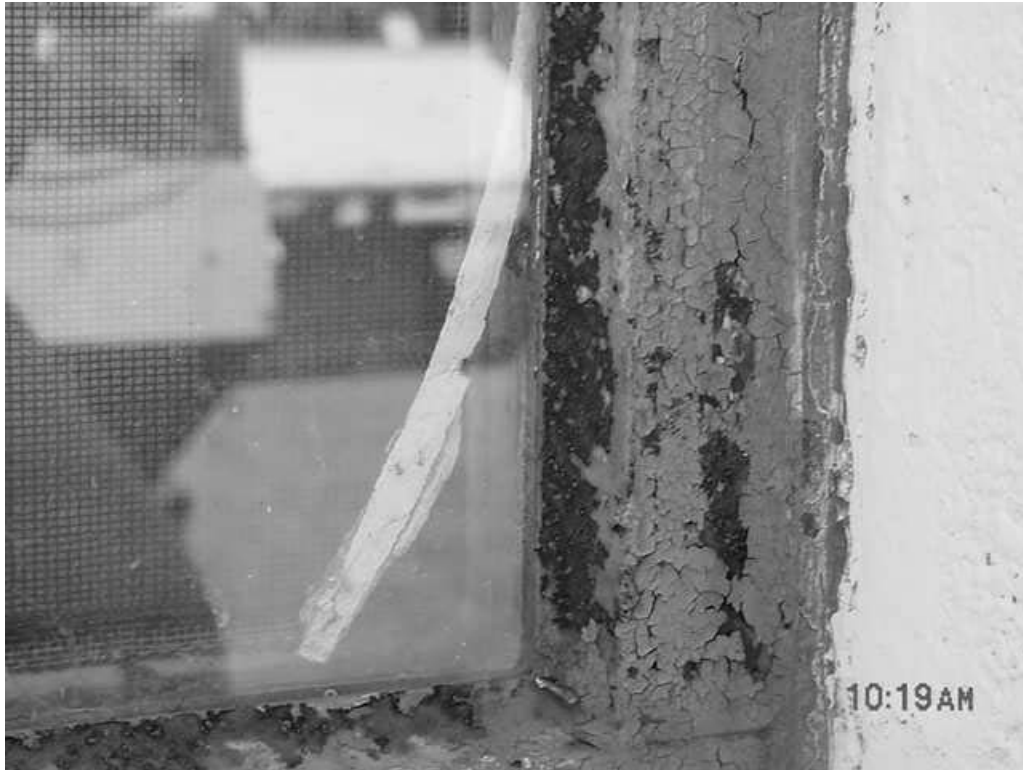
Picture 18

Missing Damaged Caulking around Window Panes

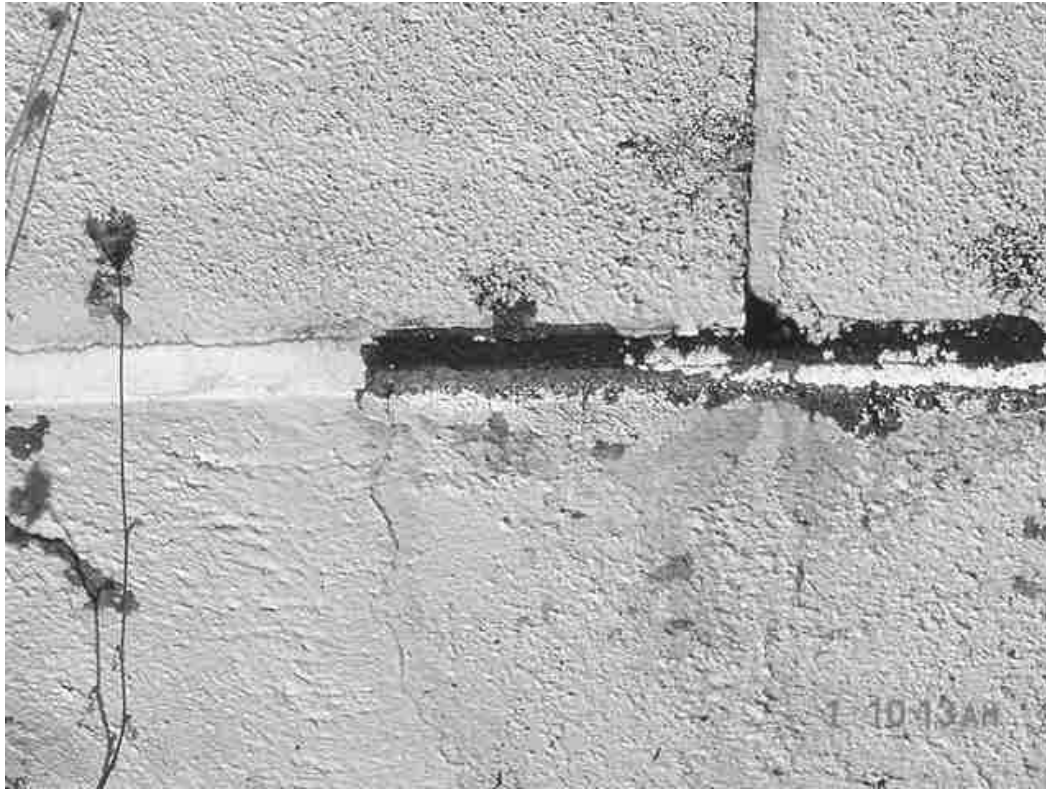
Picture 19

Missing/Damaged Mortar around Cinder Block

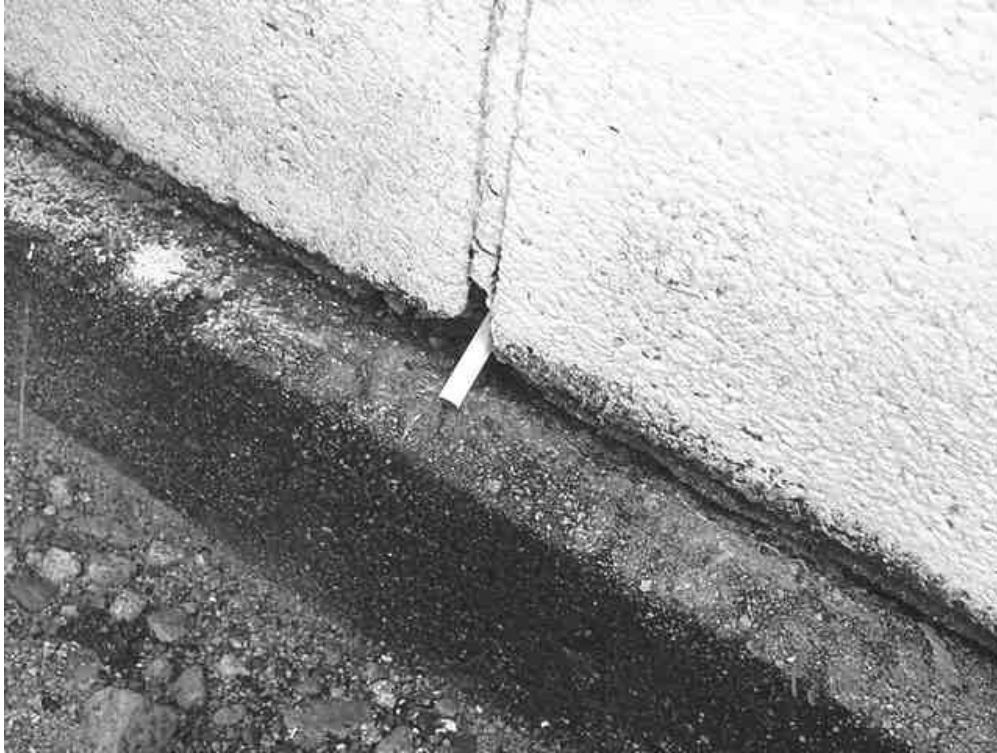
Picture 20

Missing/Damaged Mortar between Cement Slab and Cinderblock, Pen Inserted to Show Depth

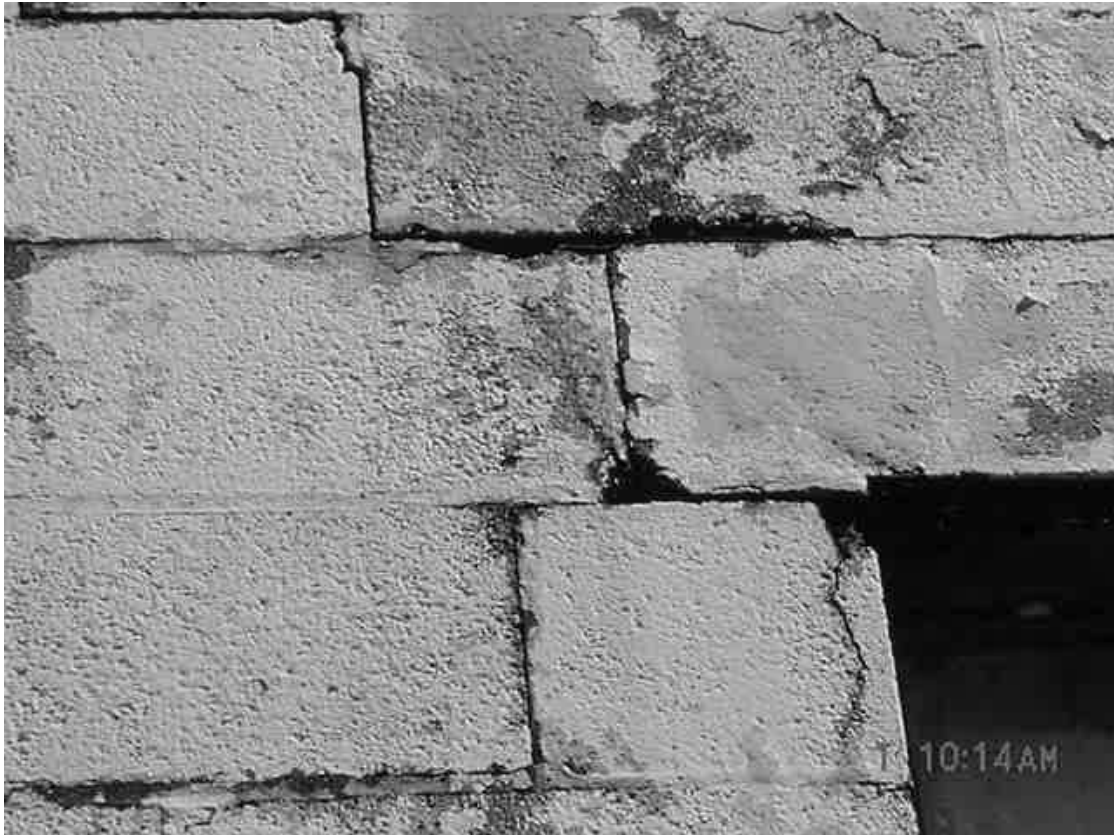
Picture 21

Missing/Damaged Mortar around Cinder Block, also Note Cracked/Broken Cinderblocks

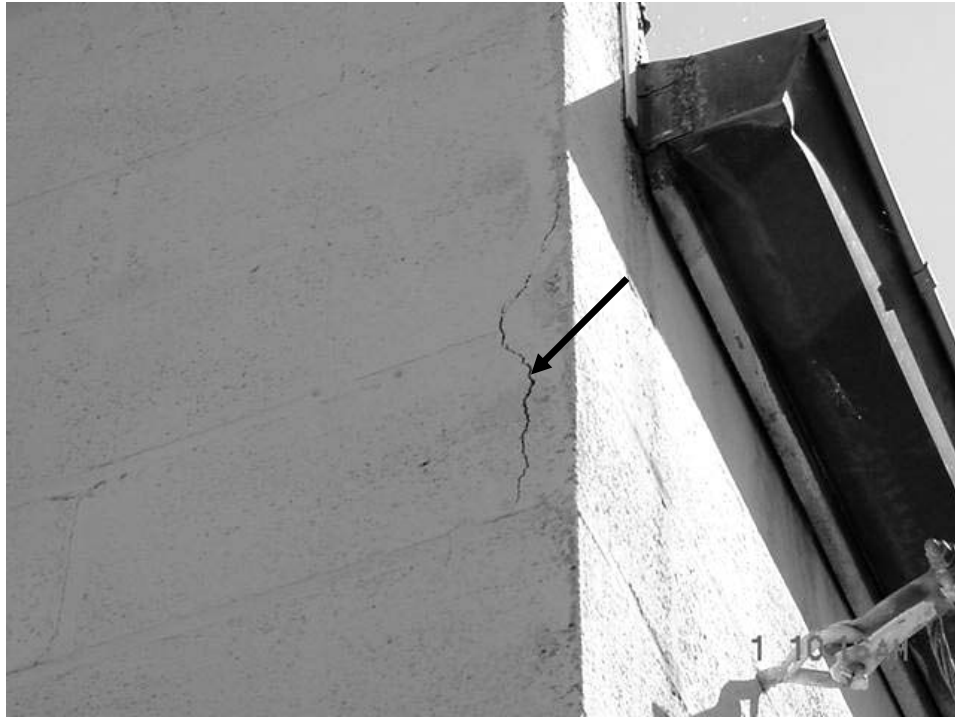
Picture 22

Cracked/Broken Cinderblocks near Roof

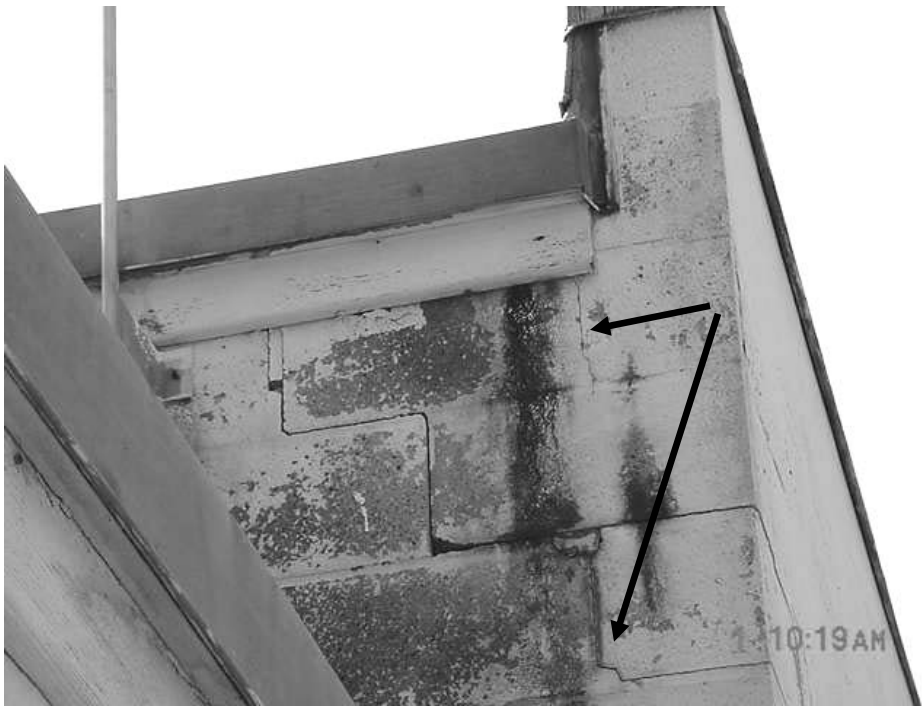
Picture 23

Cracked/Broken Cinderblocks near Roof

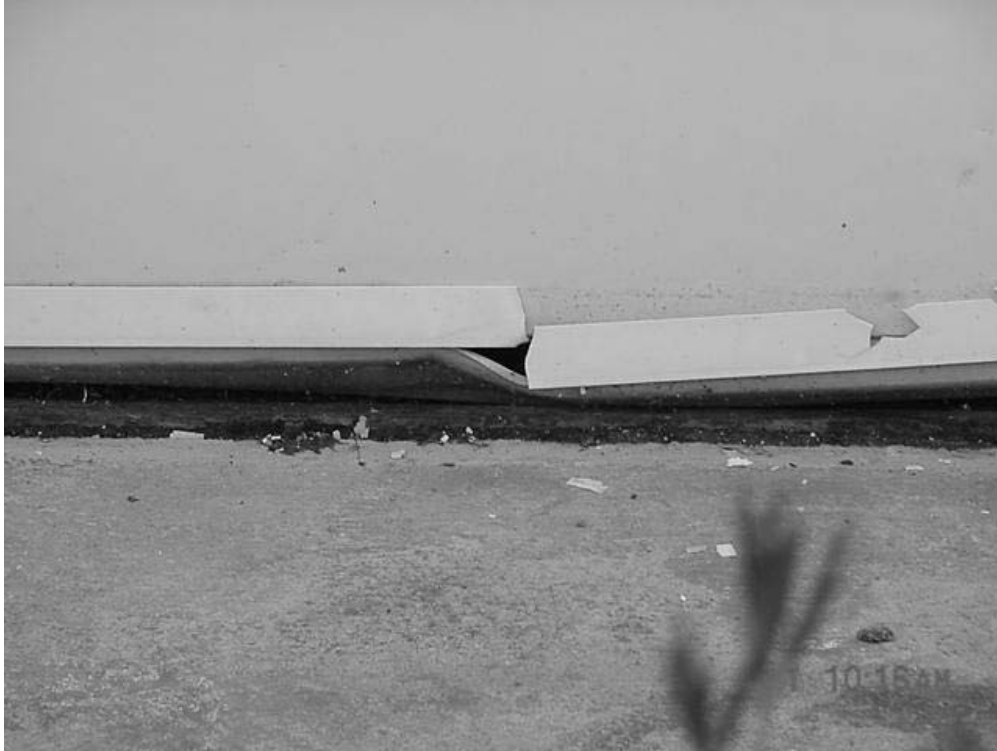
Picture 24

Broken Bottom of Garage Bay Doors
